HISTORIC STRUCTURE REPORT

FORT MATANZAS NATIONAL MONUMENT
ST. JOHN'S COUNTY, FLORIDA

THE FORT MATANZAS STABILIZATION TEAM

DENVER SERVICE CENTER
SOUTHEAST/SOUTHWEST TEAM
HISTORIC PRESERVATION BRANCH
NATIONAL PARK SERVICE
UNITED STATES DEPARTMENT OF THE INTERIOR
DENVER, COLORADO

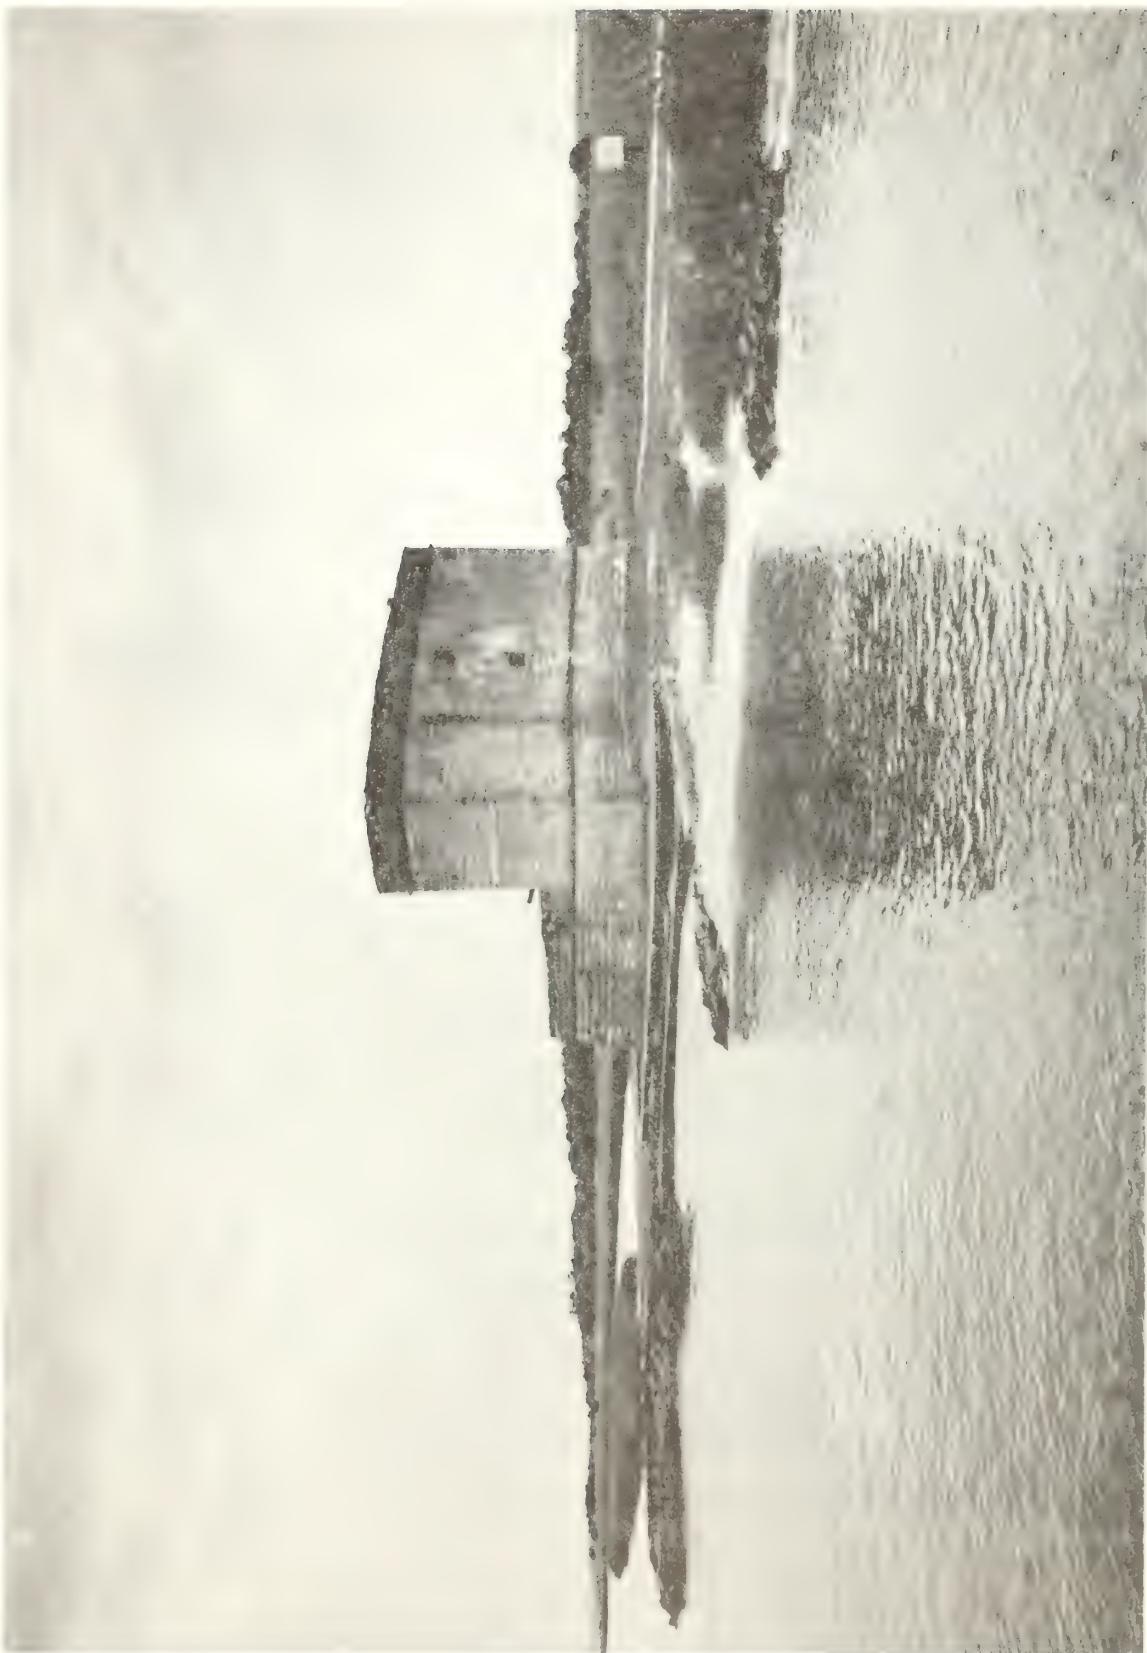
Illustration E-5

Both groins are in a deteriorated condition, with the groin nearest to the dock in the worse shape; it has little effectiveness. The groin on the north side of the coquina stone wall is in a better state and is partially responsible for the accretion of sand at the coquina seawall. Nevertheless, the condition of this groin has also declined. The armor stones are now displaced leaving the rubble core stones exposed. The position of these small core stones have been and still are disrupted during storm surges (Illus. E-5).

View of Shore East of Fort

Repair, raise and extend groin(s). This alternative will provide protection for the shore by slowing wave currents, thus retarding erosion, during normal flood and ebb tides, as well as some storm tides. Also, collection of littoral drift would increase in some areas. Possibly, total dismantling of the groin(s) may be required. This treatment will provide a solution for protection of the Fort Matanzas site. Some effect will occur relating to the flow of the Matanzas River. However, obstruction of the river flow and littoral drift would be negligible.

This treatment will provide only for repair of the groin(s). This will provide additional protection during normal flood and ebb tides. However, during high storm tides, the effectiveness of the groins would be reduced because of the flow of current over the groins. Because the groins were underdesigned initially, this alternative will need to be incorporated into another protection feature.

The coquina stones from the deteriorated groin(s) will be removed and used elsewhere in the project. Another method of shore protection will be designed to offset the loss of the groin(s).

Deterioration of the groins will continue under this alternative. Any expected shoreline protection resulting from the groins will eventually become negligible, therefore another method of shore protection will be required. Continued visual impact from the scattered arrangement will occur.

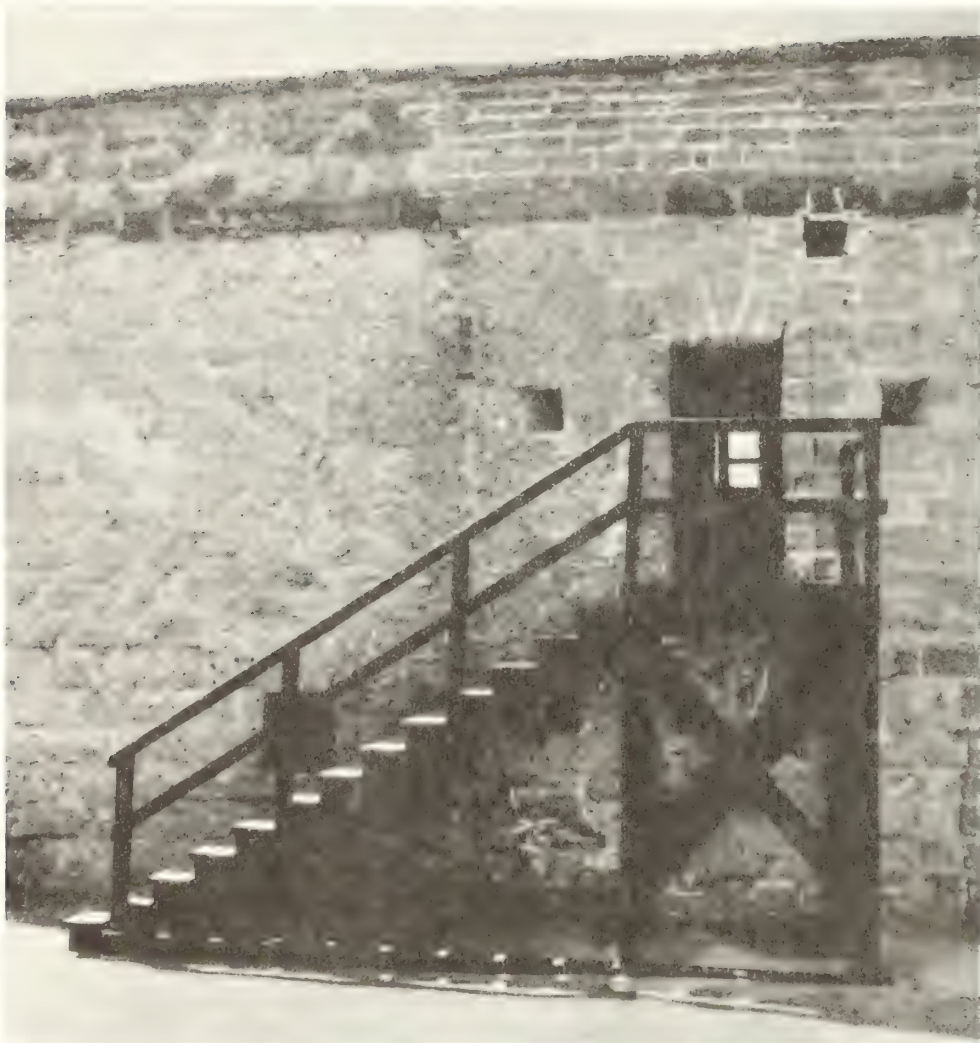
Illustration E-10

Detail of South Face and Stairs

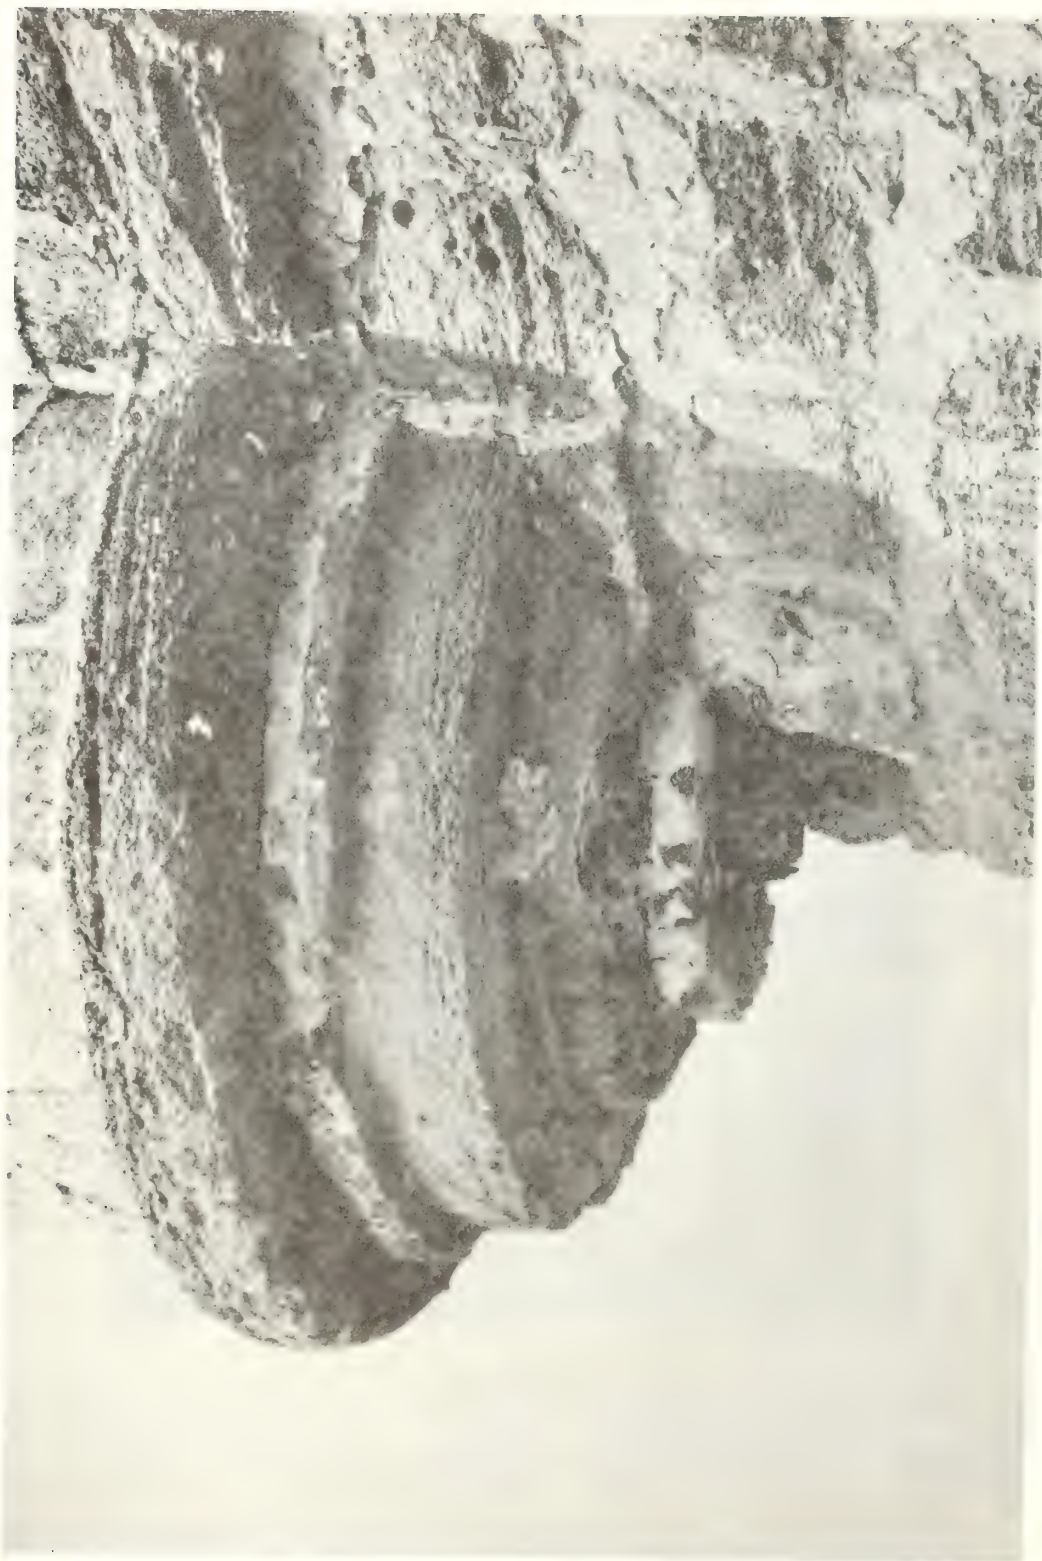
Illustration E-15

The existing sentry box is the third known to have existed (Illus. E-14). Exactly when the original feature fell off is unknown, although it was gone by 1843 as indicated by Benham (Illus. 12). Portions of the original base are still present, but suffering displacement because of rusting iron brackets used in subsequent repairs.

Detail of Sentry Box Base

Will involve an intensive maintenance/repair effort in which visible iron brackets are cut out of the corbeled masonry base; new reinforcement will be installed and corbeled base stones replaced. Architectural details of the masonry base will thus be restored. Other metal elements above the base and at the dome level will not be treated, but will require observation and maintenance as required at a later date.

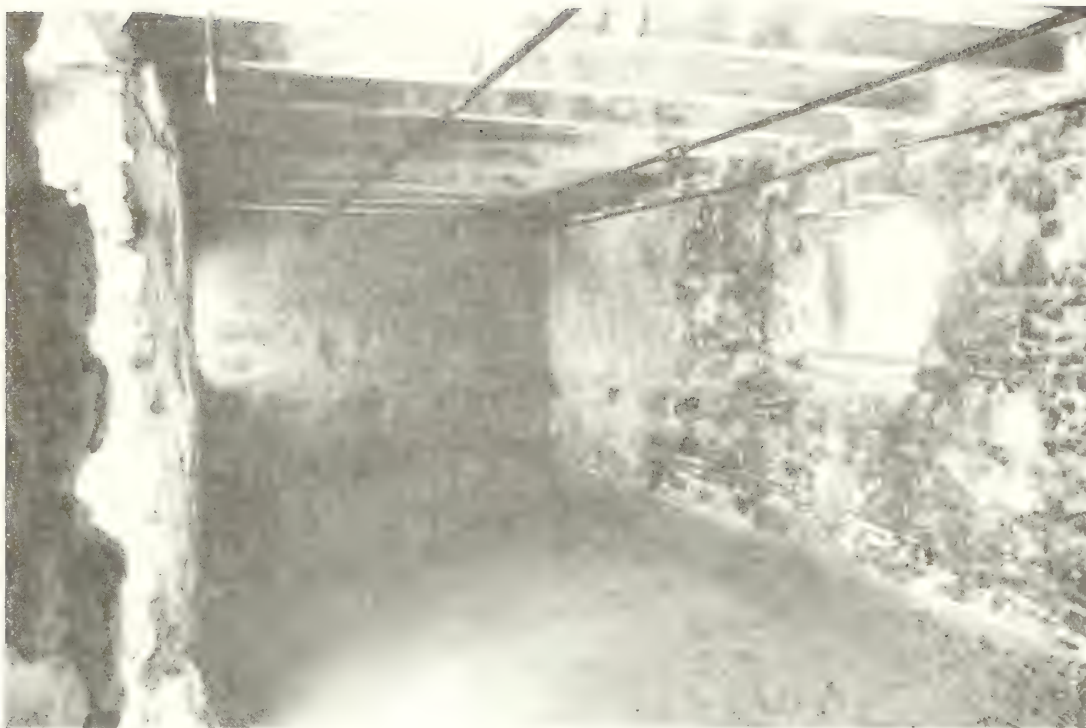
Illustration E-19

The first floor of the observation tower which housed the garrison troops and kitchen facilities has little resemblance to its historic appearance (Illus. E-19 and E-20). Although it is still about the same size (27' x 10'8") it is undifferentiated and cell-like. If rain has occurred within the previous day or two, the sandy-dirt floor will be moist if not muddy and dripping water will be coming from the decayed wooden ceiling. The visitor will notice broken and badly eroded coquina masonry around windows, the fireplace and door. Wall surfaces are also eroded with patches of plaster here and there; initials and other graffiti are cut into some stones; sloppy repointing and repairs made in the 1930s and 40s will be obvious. Visitors have, on occasion, used this space as a toilet.

First Floor Interior--Looking West

Notice joist pockets in corner.

Could be accomplished only if historic first floor grade was restored and the historic grade of the terreplein reestablished. Sill stones would be replaced and steps would be built to take the visitor down into the first floor area. Minor masonry repair, repointing, and crack filling would be necessary. Wooden door frame and door with appropriate hardware would be reconstructed.

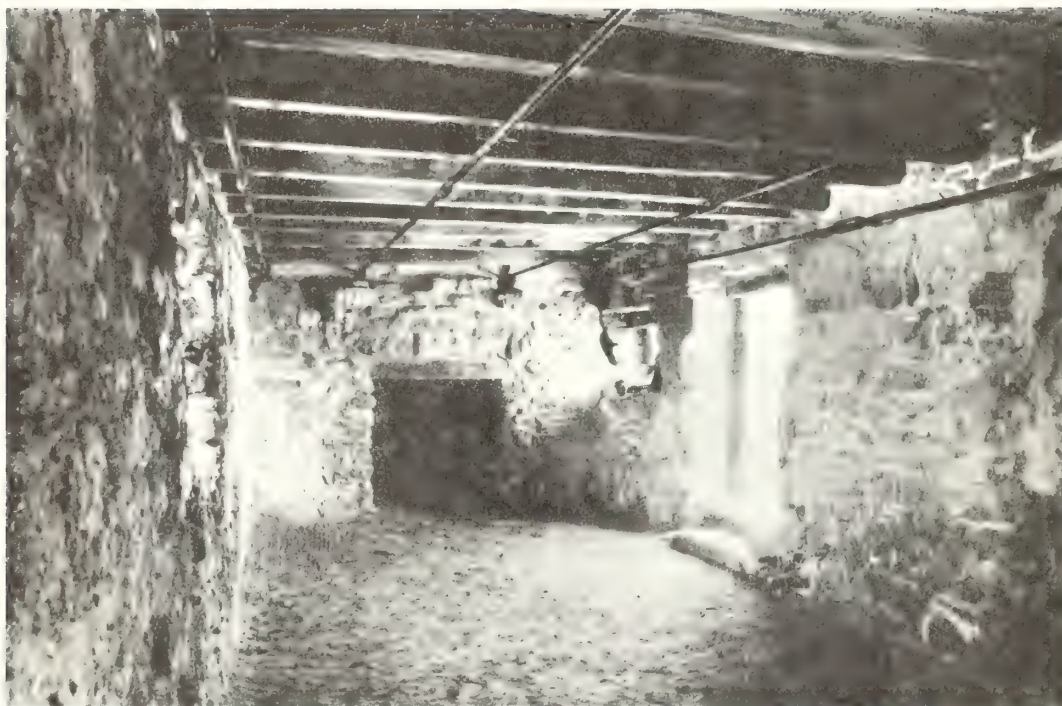
Illustration E-20

First Floor Interior--Looking East

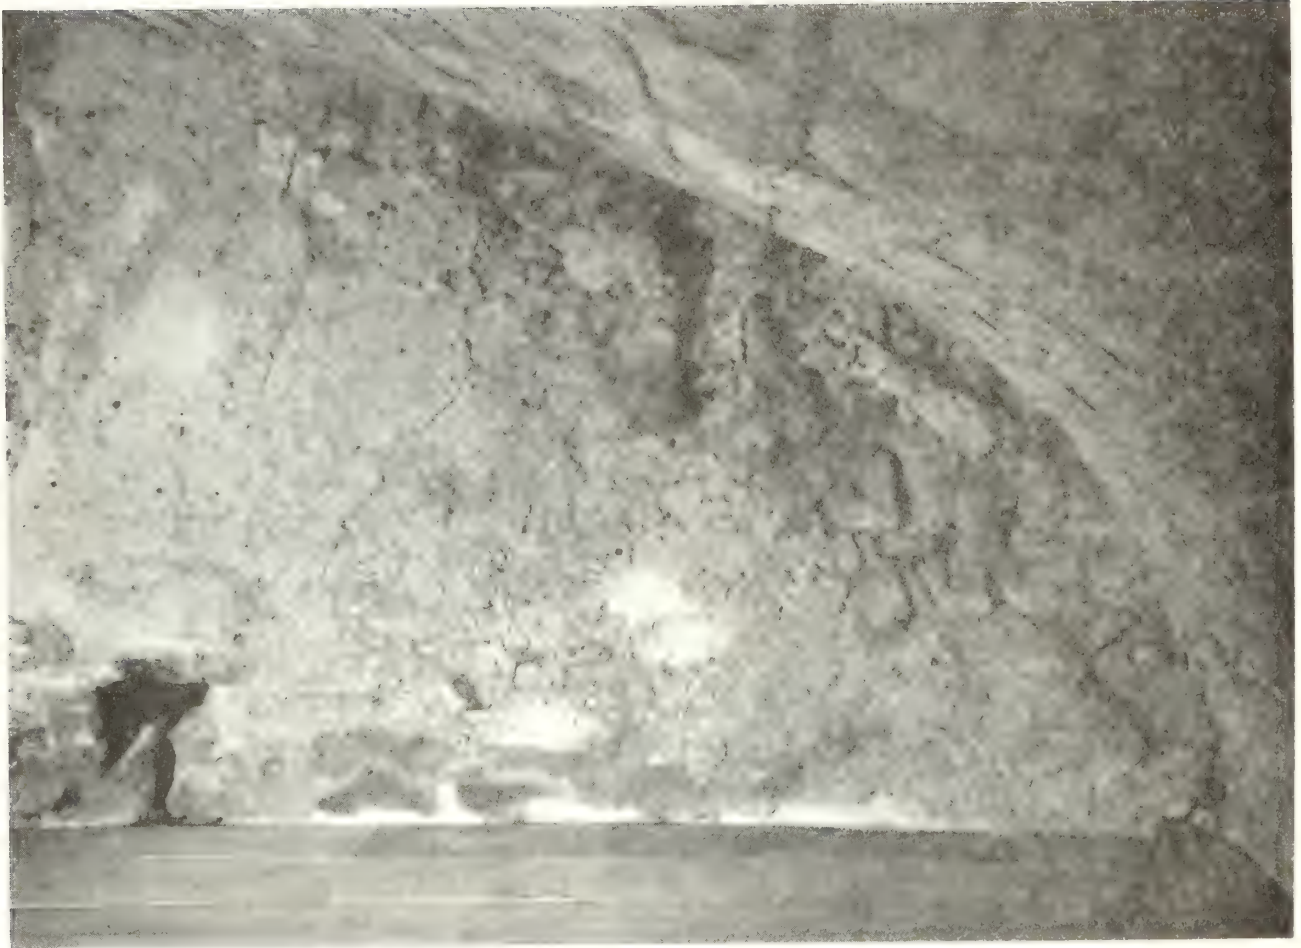
Illustration E-30

Another feature is at the east end of the north wall, roughly 4' above the floor; it is the remains of a north-south running steel tie rod used by contractor Bud Deyo in his reconstruction of

Detail of Second Floor Interior--North Wall

the tower vault in 1916. This iron fragment protruding slightly from the wall is causing little damage to the coquina fabric except for the rust stain present.

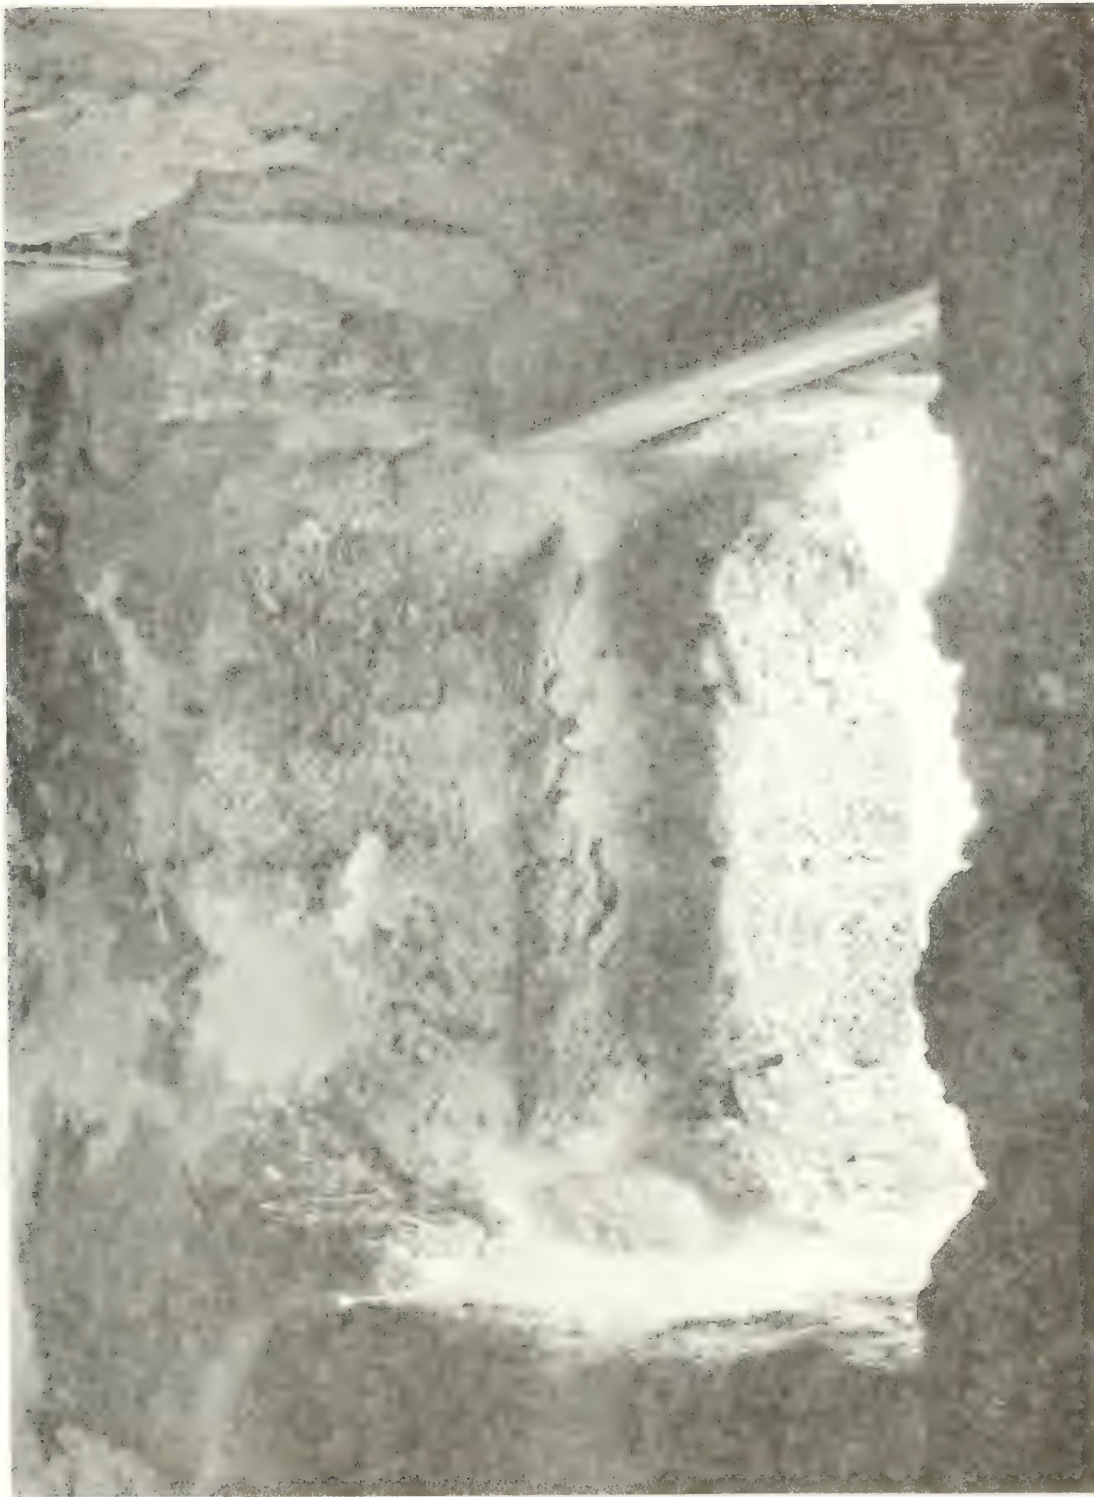
Illustration E-31

However, the major 19th century shear crack which had split the tower in half destroyed this window and the 1916 reconstruction is inaccurate. Illustration E-8 shows the reconstructed proportions as compared to the first floor window. Presently, the opening measures 2'6" high, within one or two inches of historic height, and 17"± wide, at least 7" narrower than historically.

The reconstructed vault ceiling crosses over the jack arch of the window frame obscuring 3½" of its voussoir stones. A 4" X 6" wooden lintel beam was installed in the 1916 reconstruction or more recently and is in sound condition. The opening has no protective membrane thus affording no protection from inclement weather.

As is the condition of most of the coquina fabric, the masonry window frame is pitted and badly eroded. Architectural details are nearly gone.

Detail of Second Floor North Window--Interior

Restoration would involve removing some masonry to widen the opening, replacing stones to reestablish architectural details which could accommodate wooden window frame members; installations of wooden frames and shutters with appropriate hardware.

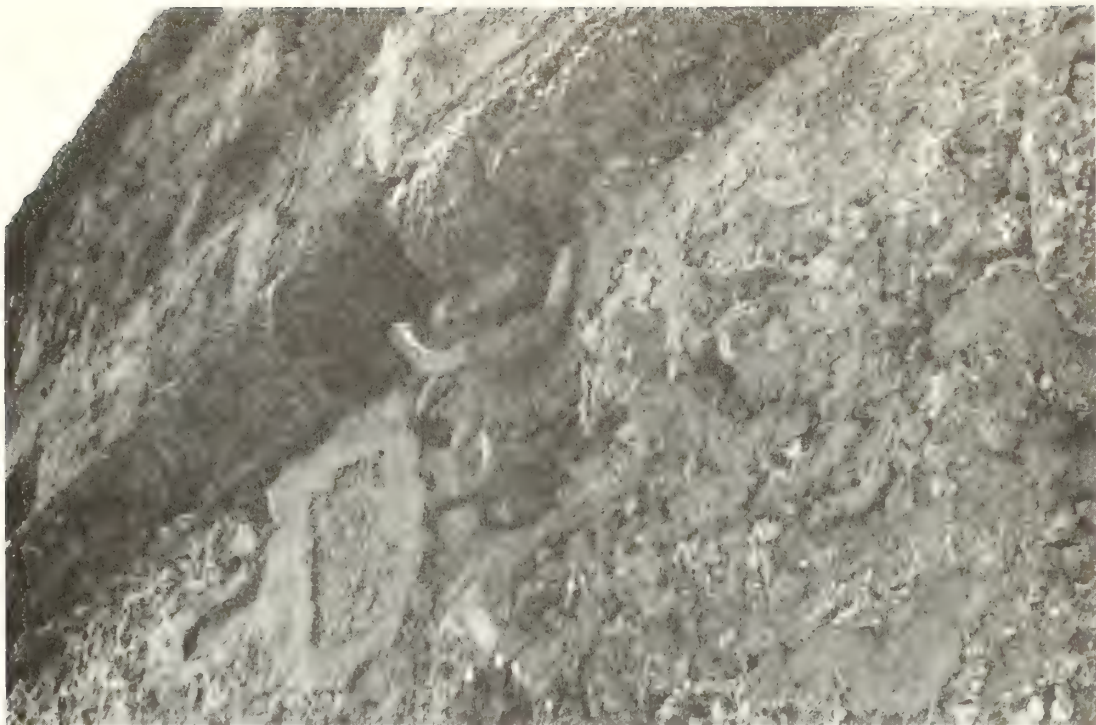
Illustration E-34

The reconstructed terreplein was graded to drain rainwater into two scuppers, one each through the north and south parapets. Although the surface is cracked (Illus. E-33) allowing seepage into the vault below and the scuppers are broken (Illus. 21, E-34, and E-35), this drainage system is functional. However, as pointed out earlier, the water is drained so as to spill onto the coquina of the tower faces accelerating their erosion. The scupper through the south parapet is in approximately its historic location and was the only historic scupper. The other one is a twentieth century fabrication probably taking advantage of a shear crack which had split the parapet at that location. Whereas the historic terreplein was sloped down from north to south at a rate of about one to twenty-four, the present surface is designed to drain in both a north and south direction.

Detail of Scupper--South Face

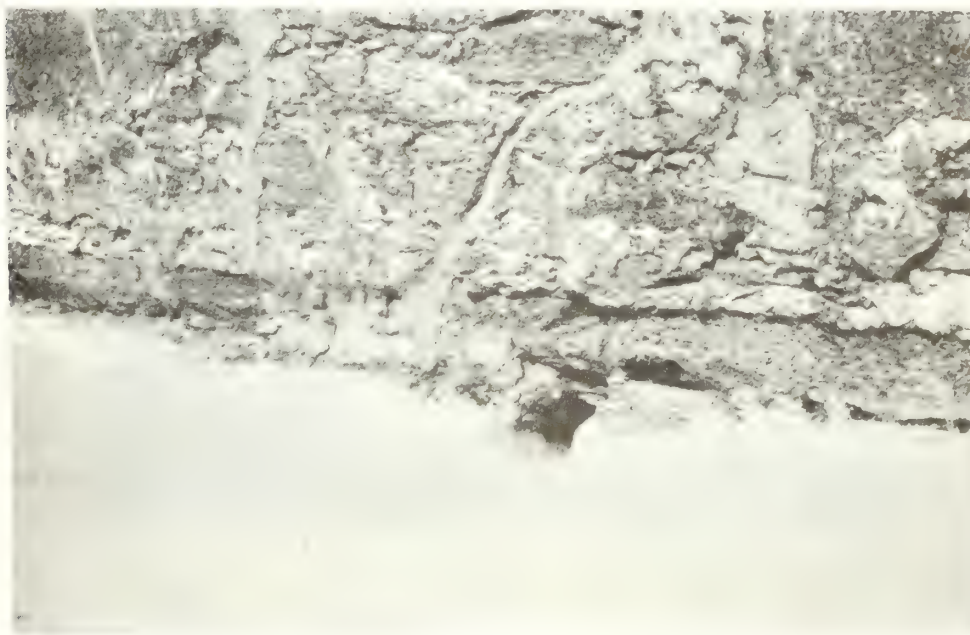
Illustration E-35

Detail of Scupper--North Parapet

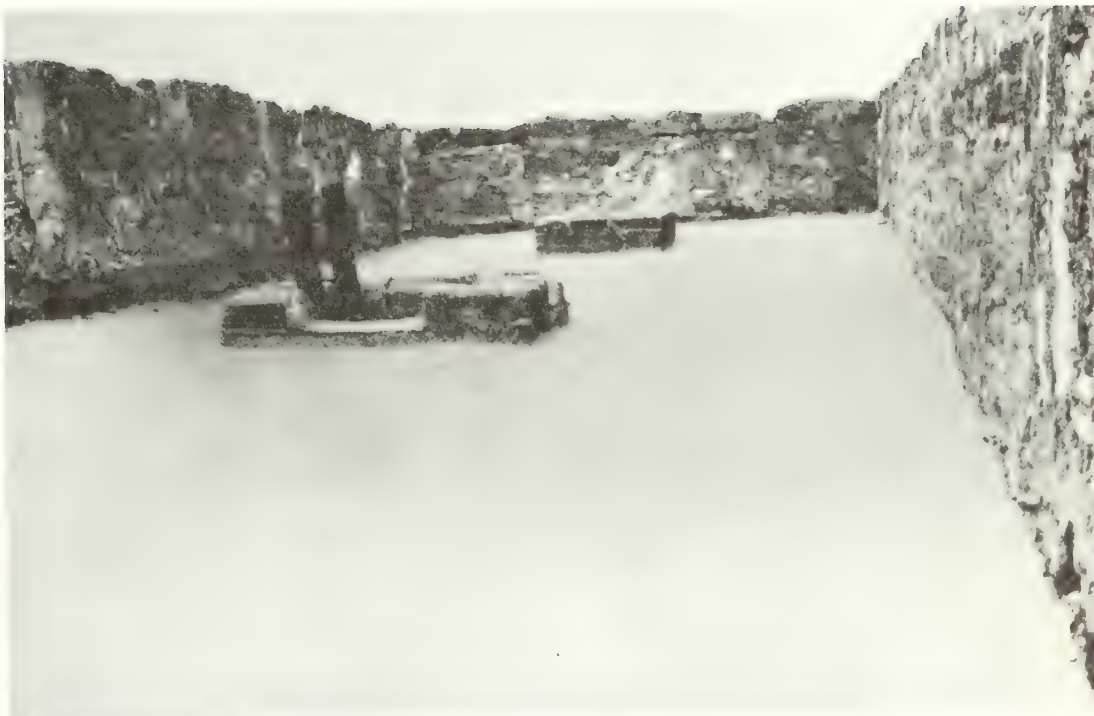
Illustration E-36

At between 20 and 22" thick, parapet walls are continuous around the perimeter of the tower deck (Illus. E-36). They exhibit deformations which reflect the splay (north, 6" and south, 4½") of the tower walls, and irregularities resulting from major shear failures with subsequent tower rebuilding (1916 and 1938-39) and general erosion (Illus. E-37 and E-38). Few patches of plaster remain on these walls and coquina erosion has been more rapid than the erosion of cement mortars used in modern repair efforts.

View of Tower Deck--Looking Northeast

replaced as necessary to restore the 1/3 superior slope and proper height. Repointing and patching of cracks and voids would be followed by a full plaster coating. Thus, protection of the coquina fabric from wind, rain and visitor impact would be achieved.

In which voids and cracks in the coquina would be filled with soft mortar and repointing performed as necessary. Some coping stones would be carved, leveled to slope so as to assure proper drainage of water off the parapet. Some badly eroded stones would be replaced. Thus, the water penetration and puddling would be alleviated.

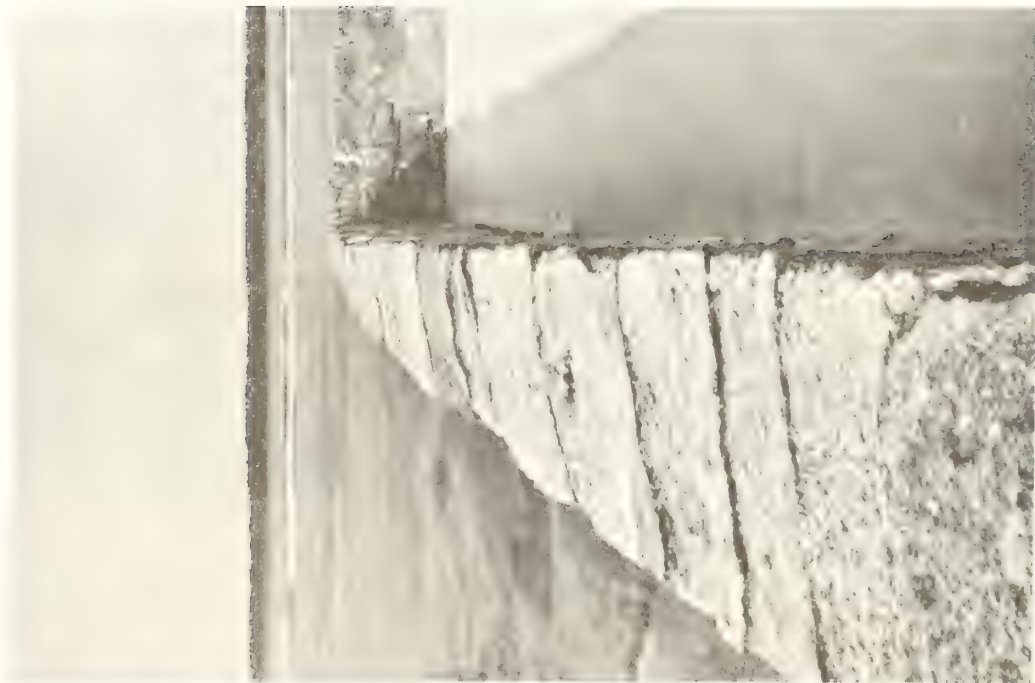
Illustration E-37

Except for 13'9" of the west end and 7'6" of the east end, the south parapet is 1939 construction. Historically, the south parapet was about 4' high. Today its height varies between 3'1" at the east end and 3'8" near the west end. The north parapet, which was about 3'6" high, more closely approaches historic height except at the west end where it slowly decreases to only 2'3". Some of this fluctuation in height is a function of the deck grade which has been shaped to drain in a non-historic pattern. Some fluctuation is also due to various amounts of erosion and inconsistencies in modern repair efforts. The north parapet exhibits the scars of three shear failures which are indicated on Benham's drawing of 1843 (Illus. 12). In 1885, Lt. Scriven believed the north parapet contained two musketry embrasures; but he most likely mistook these large broken areas for embrasures. If there were ever musketry embrasures in any of the tower deck parapets they are not adequately documented.

View Along South Parapet--Tower Deck

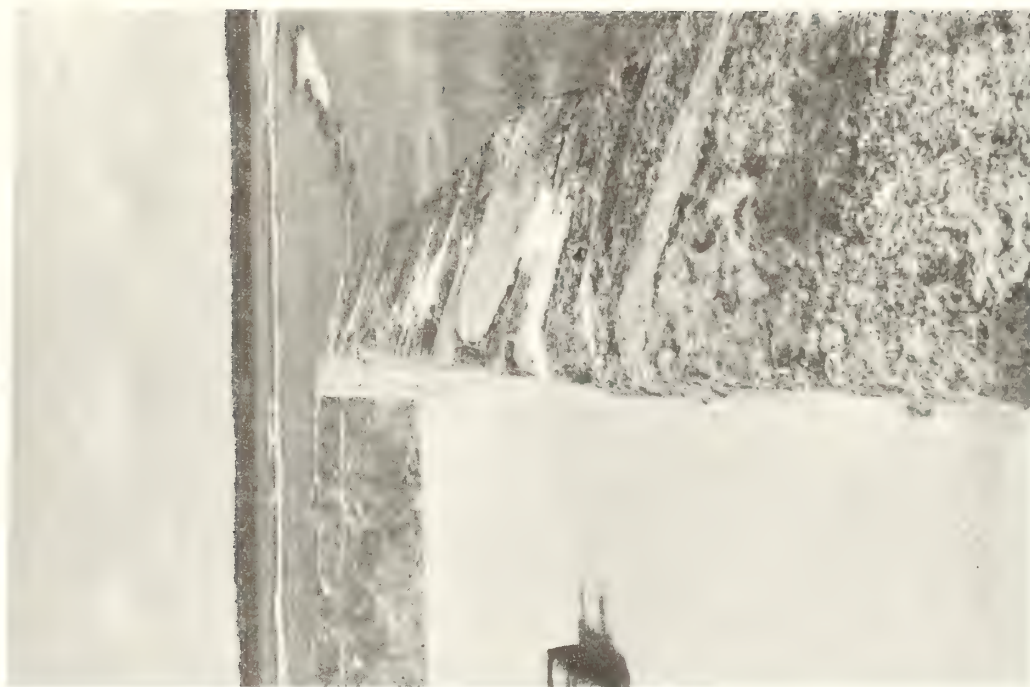
Illustration E-38

View Along North Parapet--Tower Deck

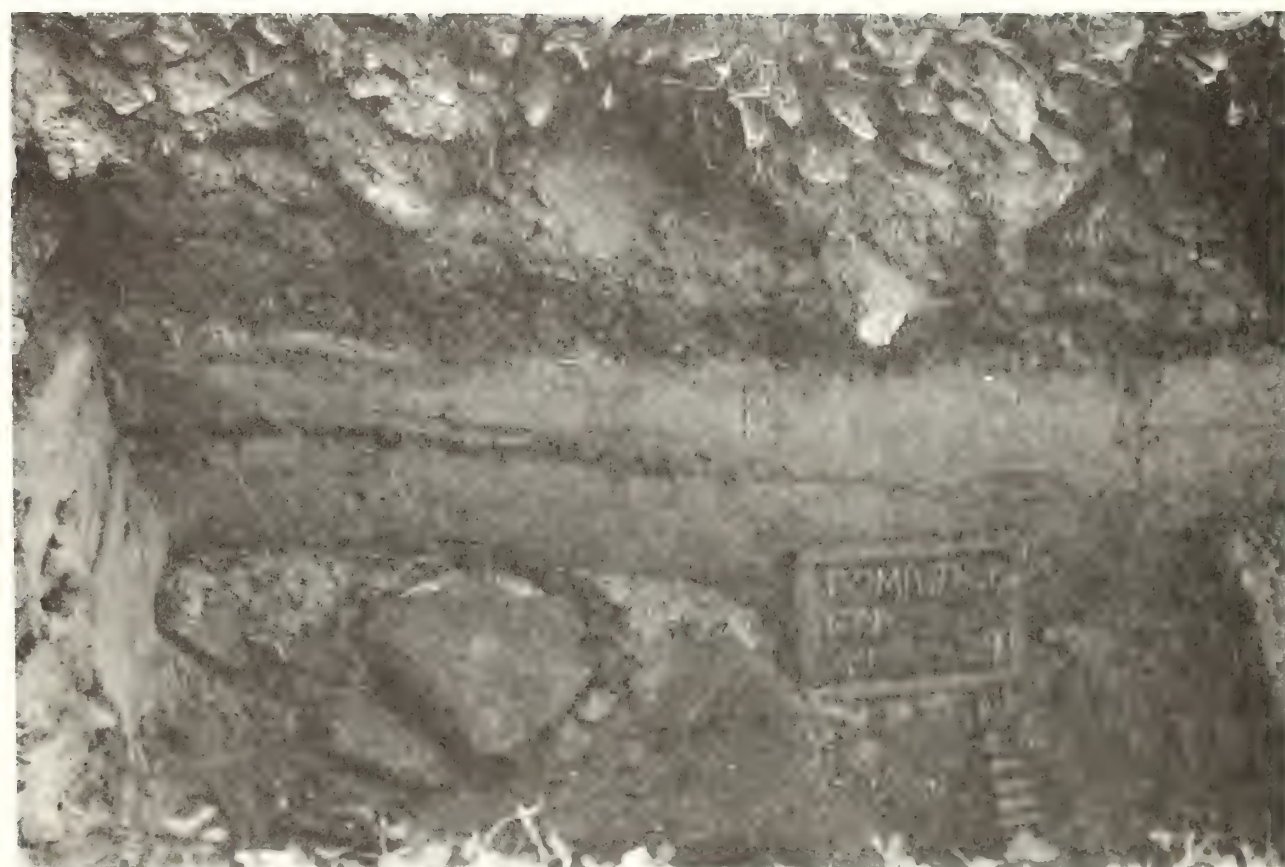
Illustration G-10b
Trench E - South profile
(East 1.5 meters of trench)
Upper 1.1 meters of trench

which may represent humic debris and storm deposit dating to just prior to the 1935 stabilization. Feature 3, below these layers (Illustration G-10b), is particularly interesting in its regularity and angularity. This is a brown humic stain present on all trench walls except the west wall, and seems most likely to have been stained from rotted planking, boards, or wood boxes. Feature 3 is present in a matrix of white beach sand, which extends to a depth of 1.75mmsl. At this level, direct evidence for the foundation of the fort, and for a possible late-eighteenth century repair of it were encountered.

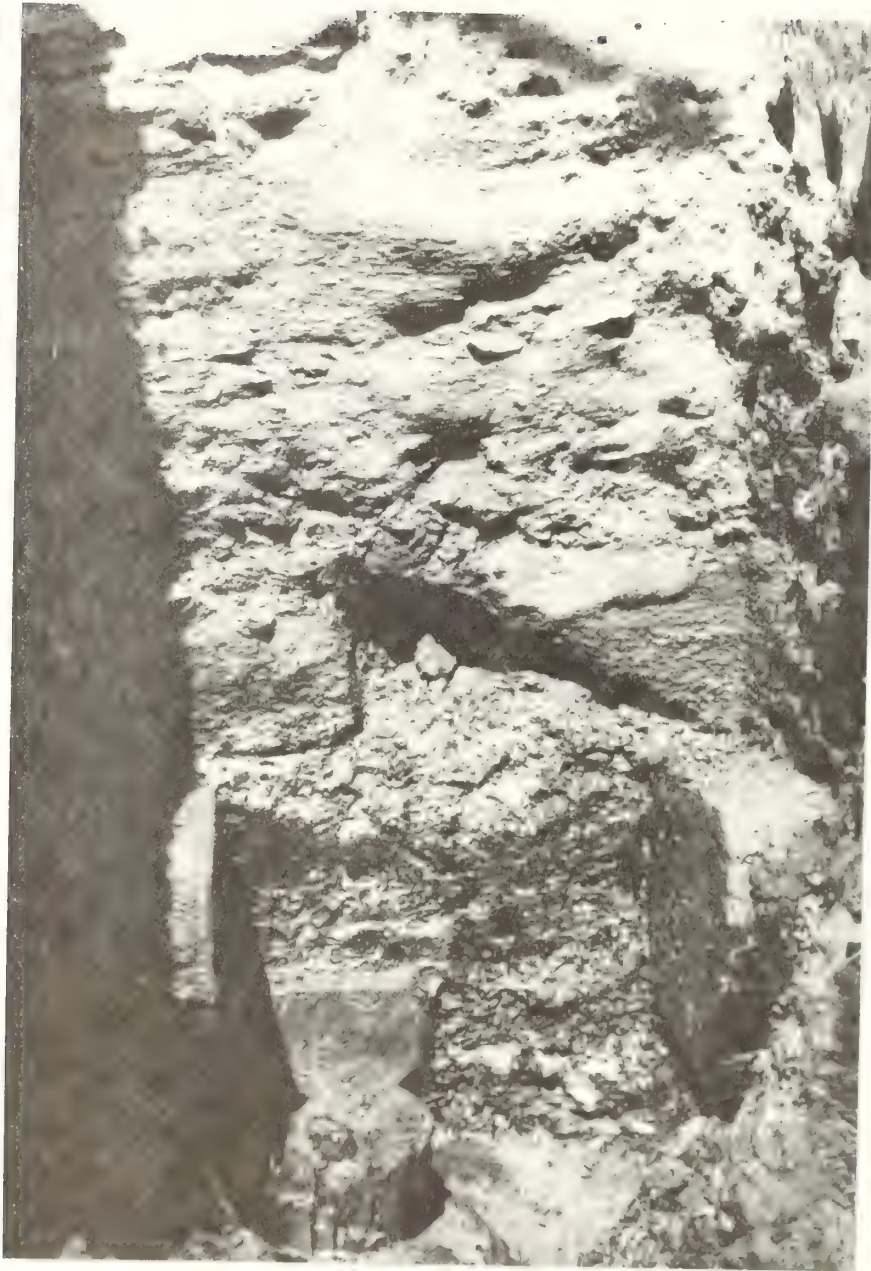
Illustration 11b
Trench E - East Profile showing
Fort foundations

Illustration G-11 (a-b) shows the stratigraphic situation of the east wall of the trench, against the fort foundation itself. Feature 6 rests against coquina blocks on the fort's west face, and rests above a horizontal support log extending east-west underneath the fort foundation at .08mmsl. The base of this

The decay of the wall is revealed in the sand- and shell-filled voids seen in profile. The upper void (sand-filled) extended for 38.5 centimeters into the fort wall, while the shell fill of the lower void was not removed in excavation. The position of the voids (as those portions of the wall most subject to erosion and ground surface activity disturbance), the change at that level in the size of the coquina blocks, and also the top of Feature 4 in profile (as a possible result of wall segments deteriorating and falling to the ground) all combine to suggest that the construction grade for the fort was between .7 and 1.0 meters below the grade of today (1.21mmsl to .91mmsl).

At .37mmsl., a pine log system of support was encountered seen in Illustrations G-11b and G-12. This consisted of a vertical piling 20 centimeters to the west of the base of the foundation, over which an east-west support beam was placed, extending underneath the fort wall. Above this, a massive north-south horizontal log was placed against the wall of the fort (leaving, in fact, bark impressions on the coquina blocks of the wall). This upper log was plastered on the top and bottom surfaces (but not the sides). The wooden support system was surrounded by a .50 meter thick layer of mud and oyster shell, which extended to the west of the fort for a distance greater than 3 meters. Artifact and stratigraphic evidence suggest that the uppermost pine log (Feature 6) and Zone 4 of this excavation were the result of the de Salas 1796 foundation repairs. While no artifact evidence exists to support or disprove the in-situ originality of the two lower wood support pieces, stratigraphic evidence suggests that this is the case. For more detailed descriptions and measurements, refer to Section 6.

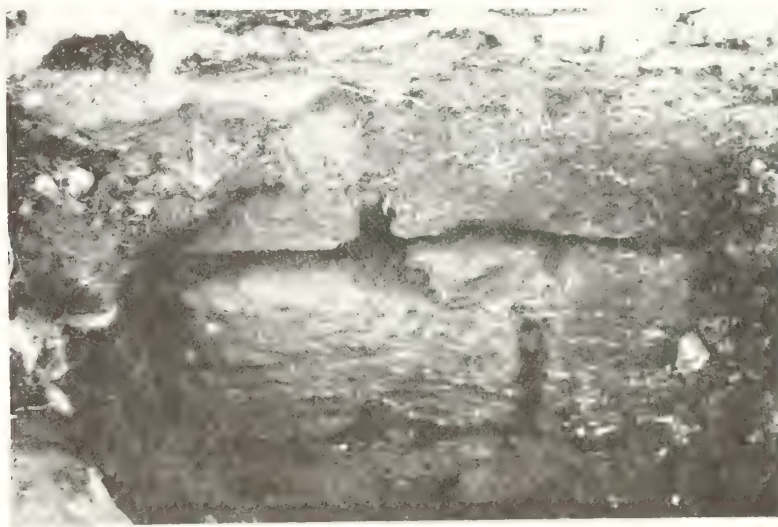
Illustration H-2

Dig Number 4 - Along West Scarp

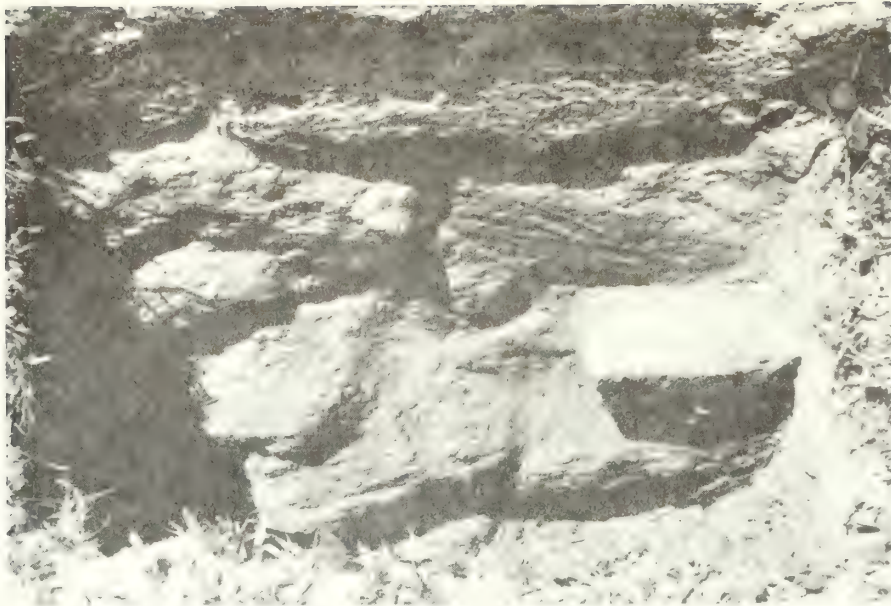
Illustration H-3

Test Dig at Northwest Corner

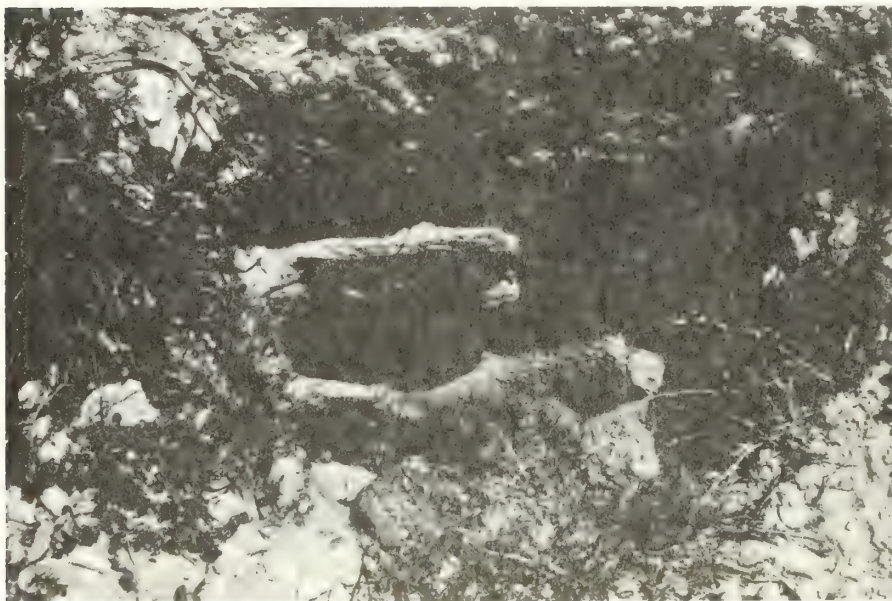
Illustration H-4

Dig Number 1 - Along East Scarp
